# Abrasivity of soils in TBM tunnelling

In the first of a series of three articles, B Nilsen, from the Norwegian University of Science and Technology (NTNU), F Dahl, of SINTEF Rock and Soil Mechanics, J Holzhäuser, of Babendererde Ingenieure, and P Raleigh, of Babendererde Engineers, discuss the impact of abrasive ground on TBM tunnelling

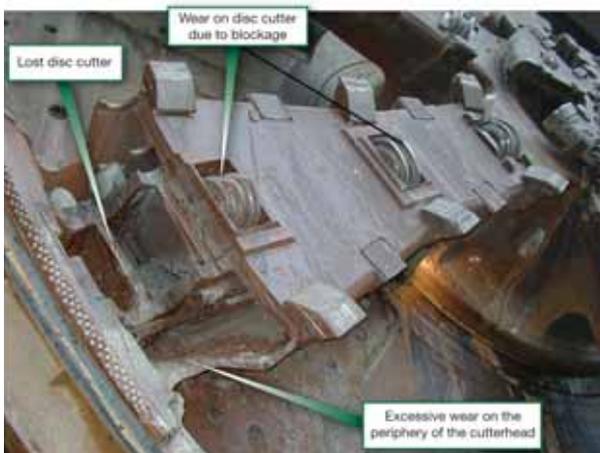
Fig 1 - Excessive wear on the cutterhead of the Wesertunnel's Ø11.7m Slurry-TBM

The examples in figures 1 and 2 illustrate the extent of wear that can be observed on soft ground TBM tunnel projects. If primary

wear remains undetected and the carbide inserts on drag bits or the disc cutter ring steel and hub body of these tools fitted to the face of the cutterhead become excessively worn, subsequent secondary wear on the cutterhead structure itself can develop rapidly, as observed on the periphery of the cutterhead after breakthrough of the first tube on the Wesertunnel in Germany (see figure 1). As shown, sticky clay can block disc cutters from rotating, so that they are immobilised in one position and are ground down on one side (flat-spotted).

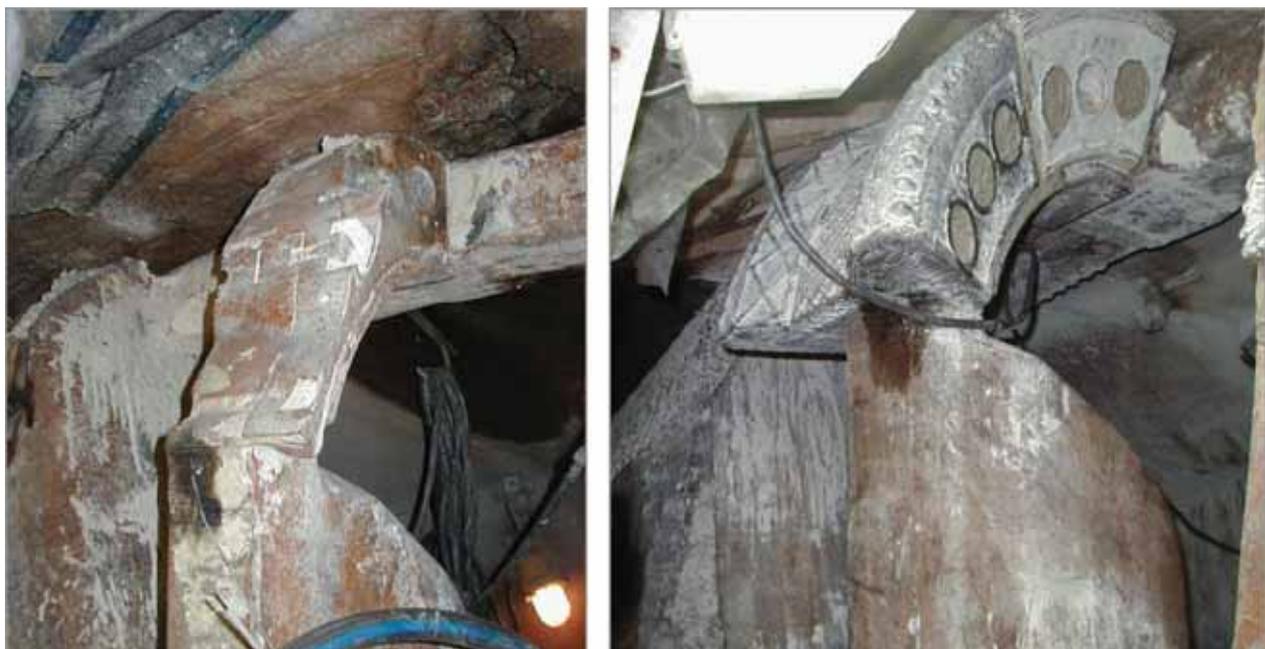
Fig 4 - Bucket tool before repair showing wear through fixing bolts (left) and after repair (right)

Figure 4 illustrates the peripheral area of the cutterhead before and after repairs had been affected underground adjacent to the 24 do Agosto station, on the Porto Metro. The wear was largely due to the abrasive Porto granite in its various states of weathering. The use of closed mode (EPB) operation where the TBM excavated mixed soil conditions also contributed to the observed wear, which required some six weeks of around-the-clock working in order to complete the cutterhead refurbishment.
