Stability and water leakage of hard rock subsea tunnels

ABSTRACT: The many undersea tunnels along the coast of Norway offer excellent opportunities to study the key factors determining stability and water leakage in hard rock subsea tunnels. About 30 such tunnels have been constructed in Norway the last 20 years, all of them excavated by drill and blast. The longest tunnel is 7.9 km with its deepest point 260 metres below sea level. Although all tunnels are located in Precambrian or Palaeozoic rocks, some of them have encountered complex faulting or less competent rocks like shale and schist. The severe tunnelling problems met in these tunnels emphasise the need of a better understanding of the key factors determining stability and water leakage of such projects. This has been discussed based on the experience from several completed projects.

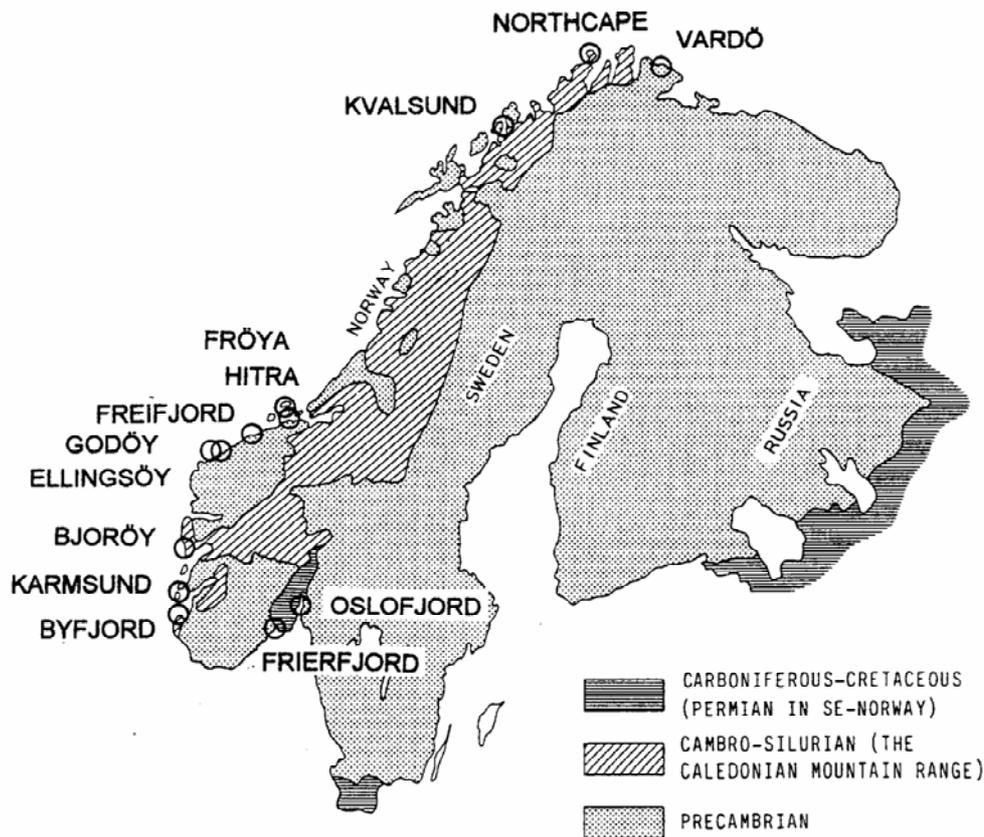
Figure 1. Locations of some of the main Norwegian subsea tunnel projects.

In Norway, about 30 subsea tunnels, comprising more than 100 km have been built the last 20 years. Most of these are 2 or 3 lane road tunnels, but some are also for water, sewage, or oil and gas pipelines. All tunnels so far are drill and blast. The locations of some key projects, and tunnels being discussed later in this paper, are shown in Figure 1, and some main figures concerning length and depth are given in Table 1.

The consequences of cave-in or severe water ingress in a subsea tunnel may be disastrous. Thus, despite the fact that Norway is a hard rock province, forming part of the Precambrian Baltic Shield as shown in Figure 1, the subsea tunnels often encounter faults of very poor quality, causing challenging ground conditions.

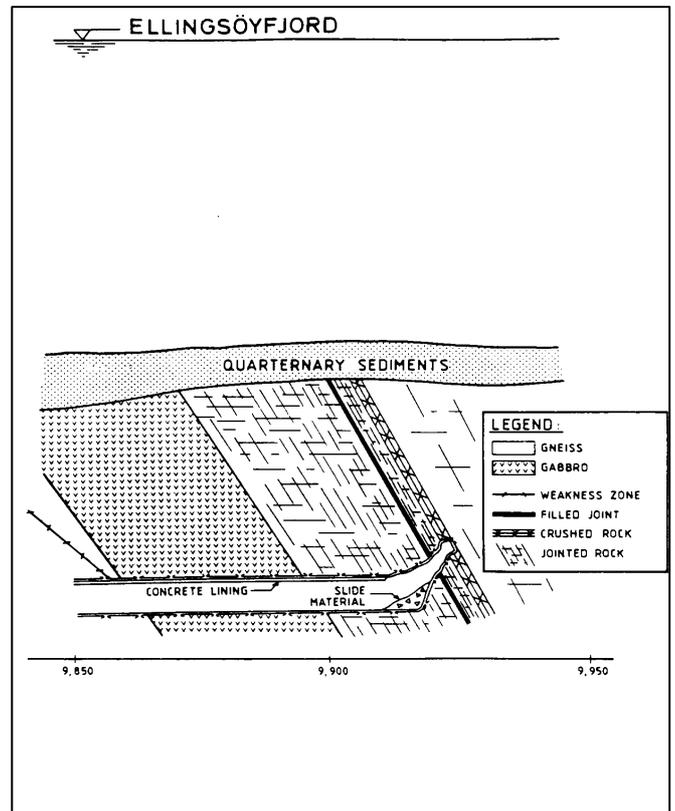
Figure 2. Cave-in situation at the Ellingsøy tunnel (based on Olsen & Blindheim, 1989).

Stability problems due to major weakness zones represent a threat to hard rock subsea tunnel projects. In some cases, severe instability has occurred. In the majority of such cases, the problem has been caused by faulted rock carrying clay minerals and water leakage of relatively high pressure. One such case was the Ellingsøy road tunnel, see Figure 2. Here, despite the fact that continuous probe drilling was carried out, a fault zone containing swelling clay and water-bearing fissures caused a cave-in reaching up to 8-10 meters above the crown before it finally stopped after 24 hours. A concrete plug of approximately 700 m³ was constructed in order to ensure safe tunnelling through the zone.

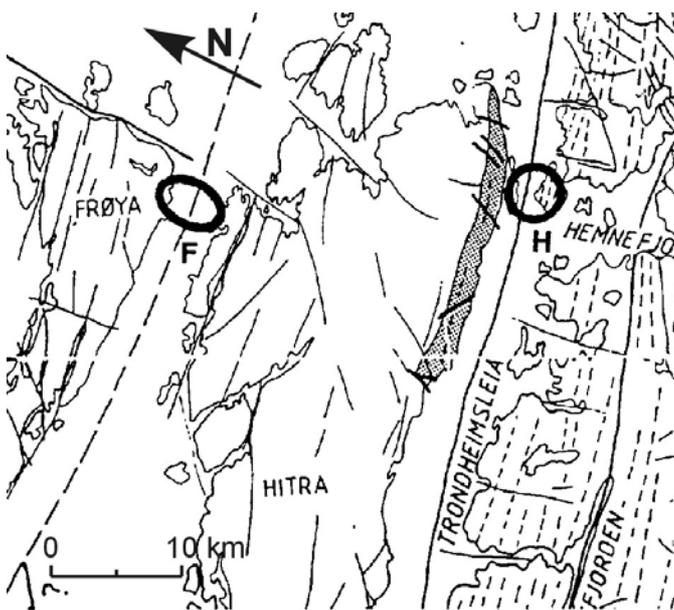
Figure 3. Pattern of regional faults in the area of the Frøya (F) and Hitra (H) subsea tunnels. Shaded area is Palaeozoic rock, the rest Precambrian (after Grønli, 1991).

In the Frøya subsea tunnel project area, a pattern of very distinct, regional faults were identified, see Figure 3. Some of these faults can be followed over a distance of more than 200 km.

In the Frøya area, the minor principal stress is most likely oriented NE - SW (parallel to the coast line), see Figure 3, and NW - SE oriented discontinuities thus in theory are most likely to give major inflow. Because of the location of the Frøya tunnel so far to the West, some of the same effects as in the Godøy were expected, but (swelling) clay content in most joints and zones resulted in small water leakage.

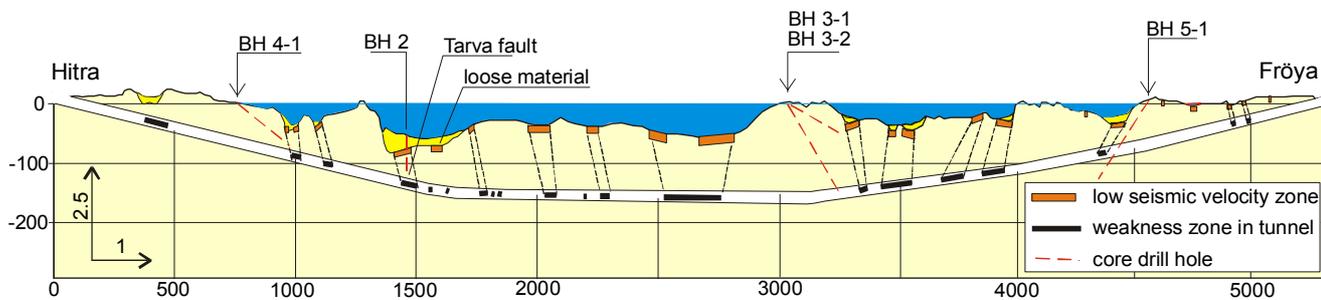
Figure 4. Longitudinal section along the Frøya tunnel

Compared to conventional tunnels, subsea tunnels are quite special in several ways. Concerning engineering geology and rock engineering, the following factors are the most important (see also Figure 4):

Tunnelling for the Frøya project started in early 1998, and was completed in September 1999. The locations of the main weakness zones are shown in Figure 4, and the technique that was commonly used for excavating through such zones is shown in Figure 5.

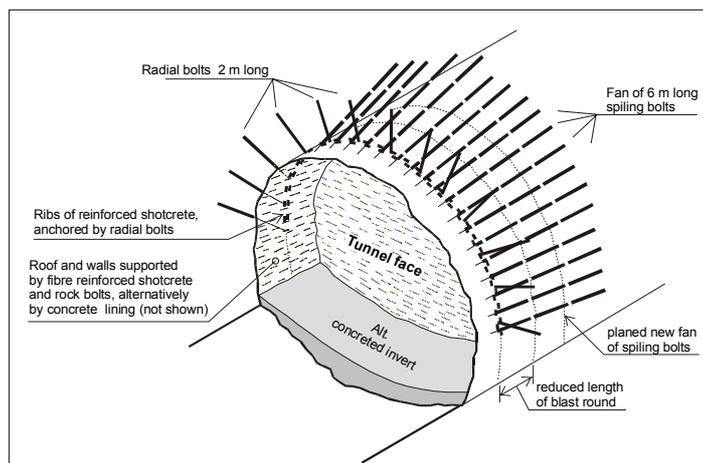
Figure 5. Principles of excavation through poor stability weakness zones applying the spiling technique (revised from Nålsund et al. 1996)

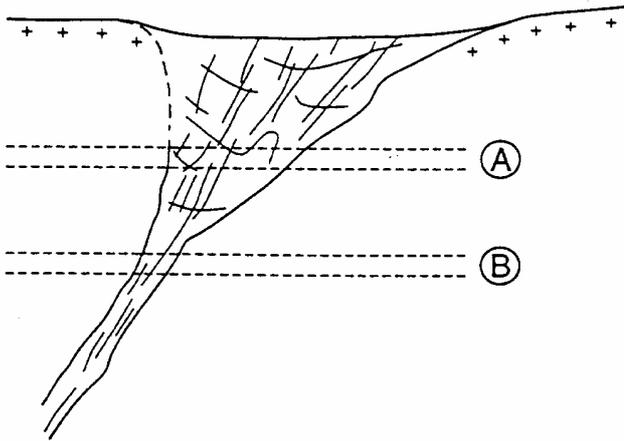
Figure 6. Principle sketch of a weakness zone with weathering root. A shallow tunnel (alternative A) gives a much wider zone crossing than a deeper (alternative B). From Nilsen et al. 1997.

In relatively recent geological time, Scandinavia has experienced several glaciations, and is thus in the favourable situation concerning rock engineering, that most weathered material has been removed by the ice. For weakness zones, particularly near the coast (far from the glaciation maximum) this is, however, not necessarily the case, as illustrated in Figure 6.

For the Frøya tunnel, located at a considerable distance from the glaciation maximum, and with a minimum rock cover of about 40 meters, the effect of weathering root is believed to play a significant role. Consequently, the effect has been taken into consideration in the evaluation of investigation results.
